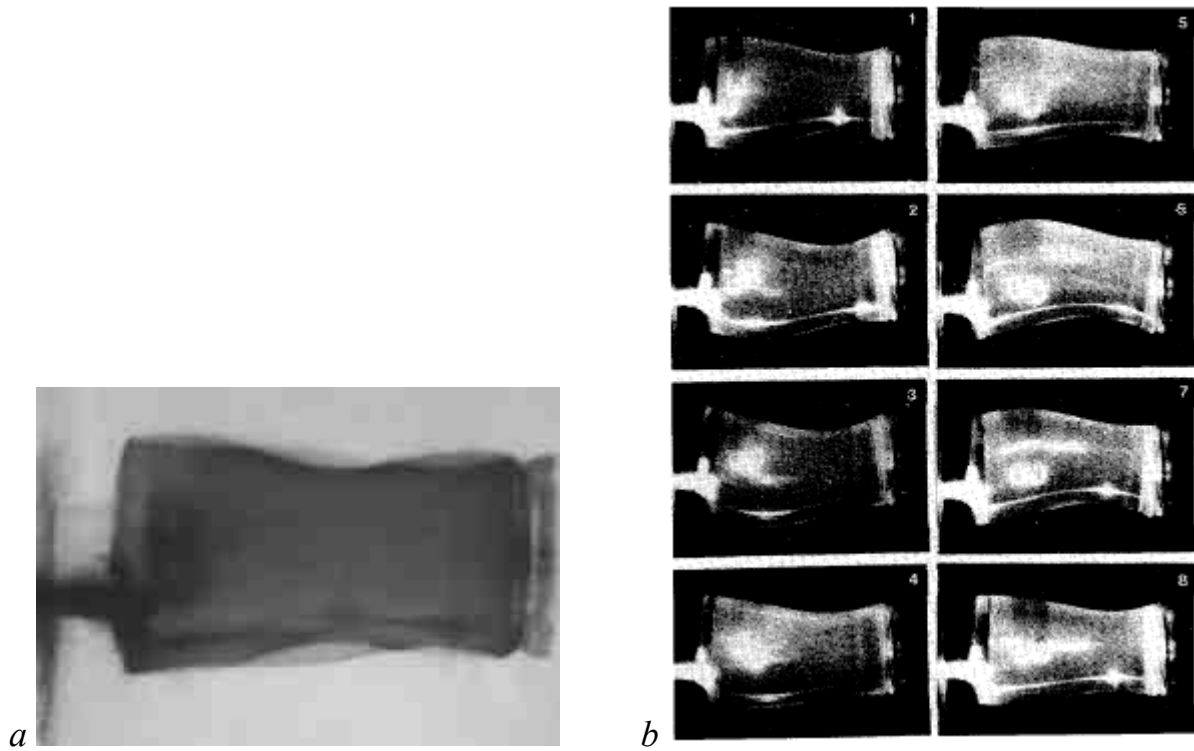
Fig. 1. Some photographs from the experiment: a) Axial vibration sequence, b) Isorotation sequence.

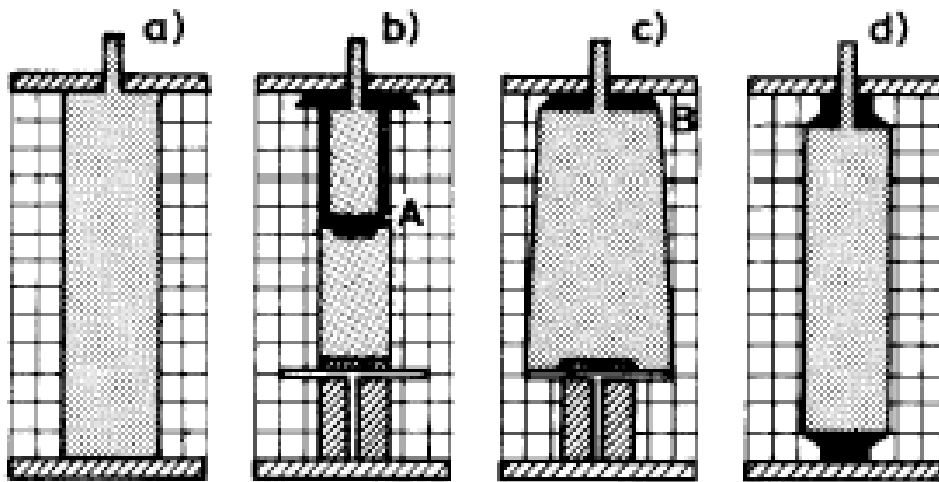
Fig. 2. Difficulties in liquid bridge formation in experiment Spacelab-1-ES-331 (1983) due to inefficient anchorage at the supports: a) Nominal configuration of 0.5 mm protruding discs of 40 mm in diameter; b) Cylindrical bridge obtained by using hand-glued hardware; c) Large non-cylindrical bridge obtained by using hand-glued hardware; d) New disc design proposed for subsequent flights. No background raster used in Spacelab-1.
